historic structure report  
architectural data section  
volume 1  
june 1985

HISTORIC STRUCTURE REPORT

Architectural Data Section

LINDENWALD

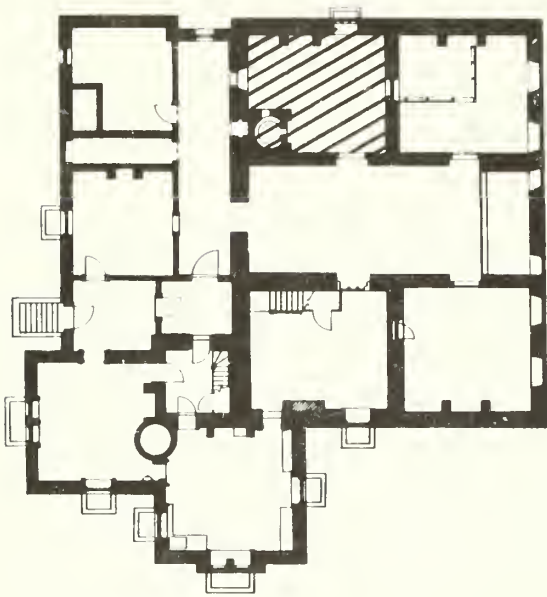
a. Room 001 - Furnace

Room 001 occupies the northwest corner of the 1797 house. To the best of our knowledge, there is no documentary or photographic evidence concerning the earliest appearance or uses of this room. The historic hot-air furnace and the modern oil-fired boiler in this room provide eloquent proof of its use from the last years of Van Buren's life to the present. (The furnace is dated to Van Buren's lifetime by the patent date "August 22, 1854" on its cast-iron firebox door and by the inscription on its sheet metal access door, "Hon. M. Van Buren/Kinderhook, N.Y.") See section IV.C.2. for a full description of the historic heating system.

Walls are unpainted stone rubble except for the white-painted brick furnace enclosure in the southwest corner and the unpainted arched brick chimney foundation on the north wall. High on the north wall west of the chimney foundation is an area of loose stonework. Near the base of all walls and especially on the furnace, mortar is powdery or has fallen out of the joints because of "rising damp." The floor is a lime mortar wash, roughly  $\frac{1}{2}$ " thick, over sand. In the middle of the room, the lime mortar has been destroyed by moisture and wear. The lime mortar is intact near the walls and extends roughly 10" up the wall surface. The floor level is lower than that of any other room in the 1797 portion of the basement. This level coincides with the bottom of the ash clean-out door of the furnace, and the furnace occupies the full height of the room, so it is assumed that the floor of this room was excavated to accommodate the furnace. (For further discussion of this point, see NPS, Fiero 1983.)

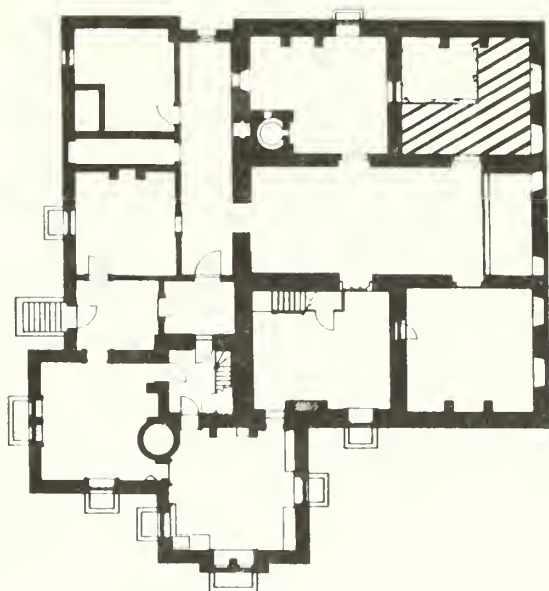
b. Room 002 - Storage

Room 002 occupies the northeast corner of the 1797 house. The northwest corner of this room was separated by a wood stud and board partition creating room 002A (discussed below). No documentary or photographic evidence relating to the historic use and appearance of this room survives. However, wrought-iron hooks in the ceiling, a "cistern" in the floor, and shelves in room 002A suggest that its primary function was food storage of some sort.

The original walls of this room are whitewashed rubble masonry with lime mortar except for the arched chimney foundation on the

- Repoint the walls as necessary.
- Remove the steam-heating pipes.
- Repair the ceiling.
- Repair the partition.
- Replace the doors.
- Repair or reconstruct the windows.
- Whitewash the wall and ceiling surfaces.
- Restore the floor.

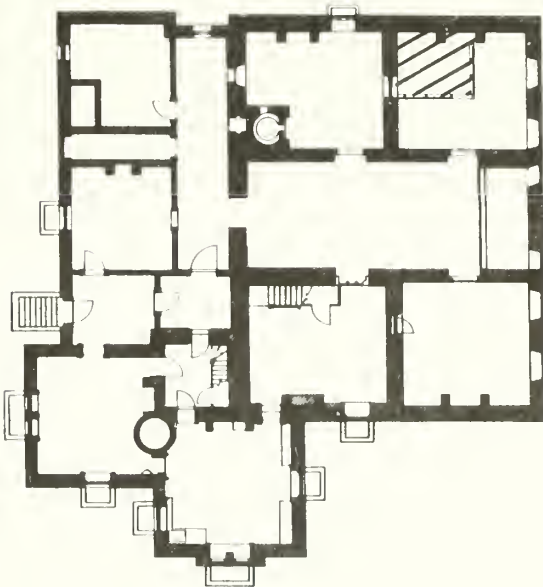
c. Room 002A - Storage

Room 002A is the space that was partitioned off in the northwest corner of room 002. It is apparent from the shelving, the lock evidence on the door, and the jars and bottles still on the floor and shelves that the room was used for food storage.

The walls of room 002A are the same as those of room 002 except that the stone walls are the north and west walls and the board partition forms the south and east walls.

Repair the shelves.

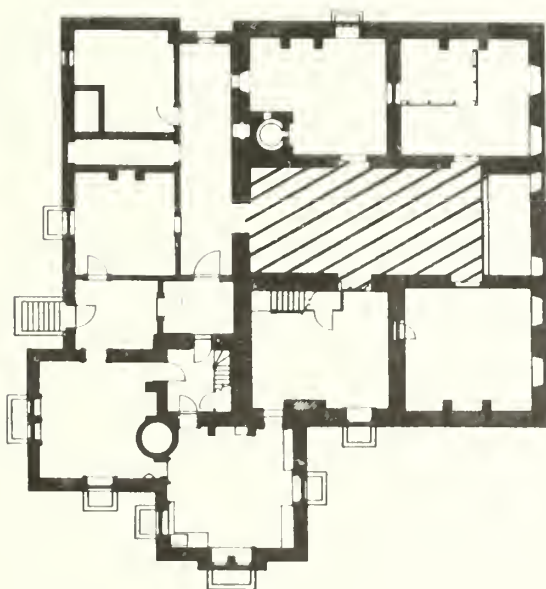
d. Room 003 - Hall

Room 003 is the central hall of the 1797 part of the basement. It provides access to rooms 001, 002, 003A, 004, and (originally but not during the historic period, 1850-62) 005. It is entered from room 012. Access was its primary function, but it may also have been used as a nonsecure storage area.

The north, south, and west walls are rubble masonry, parged and whitewashed. Crumbling mortar and peeling whitewash at the base of these walls indicate a "rising damp" problem. The east wall is a board partition, which was installed before the floor and ceiling finishes because the ends

- Improve structural reinforcement, with better footings and columns.

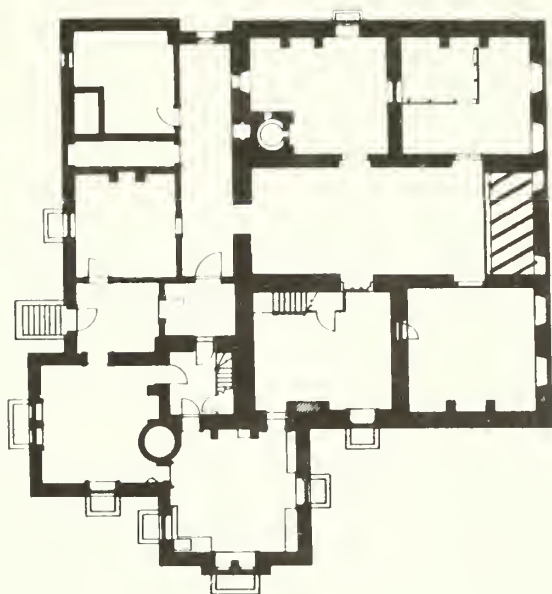
e. Room 003A - Vegetable Bin

Room 003A is at the east end of room 003. Archeological investigation seems to confirm the tradition that this room was used for vegetable storage. It may be the storeroom mentioned by Harriet Butler in her letter of May 17, 1841: "I am glad to hear from Smith that your store room is made. It will need a good lock and the key always in the hands of a trusty person" (Van Buren Papers, CCHS).

The east and south walls are parged and whitewashed rubble masonry. The north wall is two wythes of brick laid in American bond, with headers every fourth or fifth course, and whitewashed over rubble masonry. The west wall is a board partition nailed to the west sides of a 10" by 6" sill and a 9" by 6" beam (see IP019). Some of the boards are planed square, some are tongue-and-groove, and some are tongue-and-groove and beaded. The beaded boards range from 7" to 10" wide. The square edge and tongue-and-groove boards range from 10" to 11-1/2" wide. This partition was installed after the north and south walls and before the floor and ceiling.

Whitewash the walls.

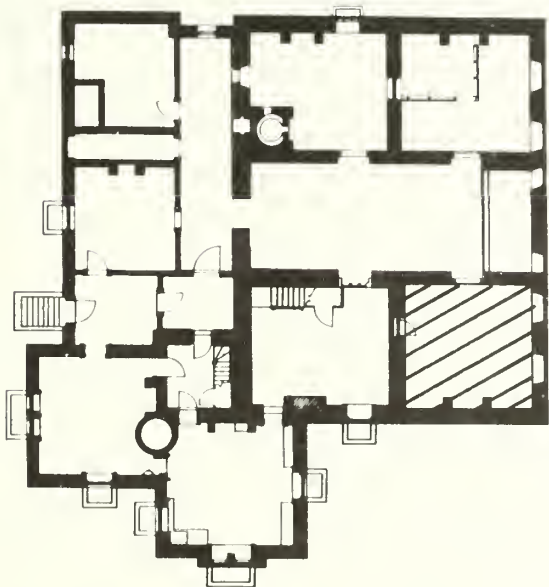
f. Room 004 - Wine Storage

Room 004 occupies the southeast corner of the 1797 basement. The surviving racks and barrels suggest that the room was used for storage of beverages. Evidence below leads to the conclusion that these fixtures are historic.

The walls are whitewashed rubble masonry with heavily mortared joints. The arched brick chimney foundation against the south wall is also whitewashed. Due to "rising damp" or infiltration of rainwater, the mortar at the base of the walls is slightly deteriorated.

Restore the bell pull system.

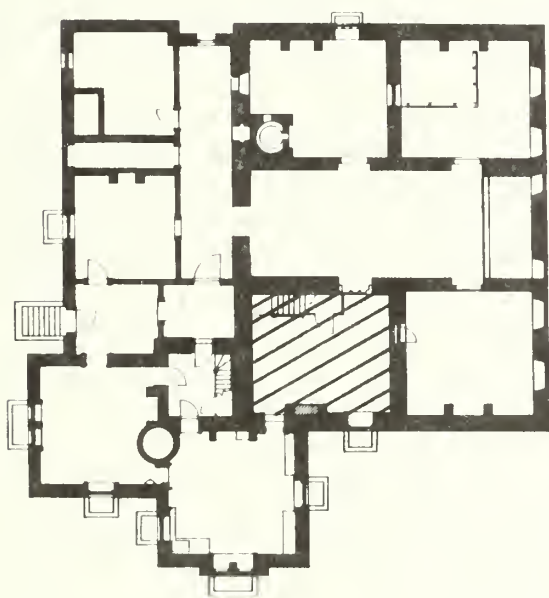
g. Room 005 - Servants' Dining and Stair

Room 005 is in the southwest corner of the 1797 part of the house. According to tradition, it was used as the servants' dining room during the historic period. The evidence of call bells, the stairs, the wallpaper, and the proximity to the kitchen (room 006) combine to add credence to the tradition.

The walls of room 005 are a two-coat plaster on wood lath attached to furring strips with ca. 1850 nails. Behind the furring strips, the rubble masonry walls are whitewashed. The plaster is covered with a striped floral wallpaper. Analysis of this wallpaper is presented in section VI.C.

Paint all woodwork (cream, Munsell 5Y 9/2, Benjamin Moore GB-60).

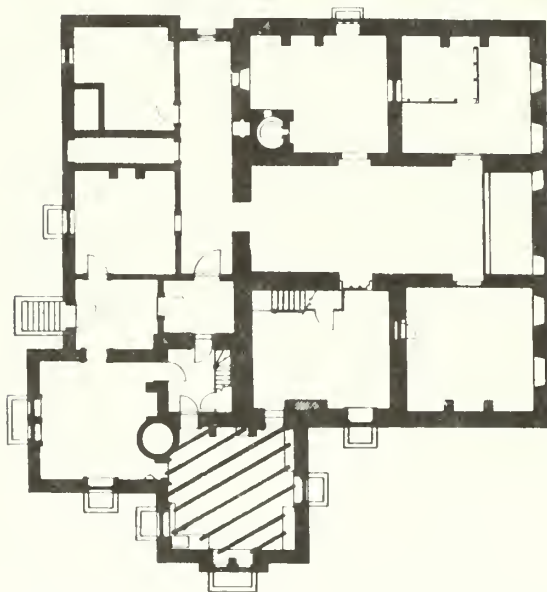
#### h. Room 006 - Kitchen

Room 006 is in the south bay of the ca. 1850 addition. It was the kitchen for the Van Buren household during the historic period. The evidence for this use consists of the cast-iron range and ovens in the north wall, the water supply, the cupboards, and the circular brick oven in the northwest corner of the room.

All of the plaster, lath, and furring strips are completely gone from the walls of this room. The exterior walls (east, south, and west) are of coursed rubble masonry with horizontal wood nailers incorporated into the construction for attachment of

- Return the shelving in room 114 to room 006.

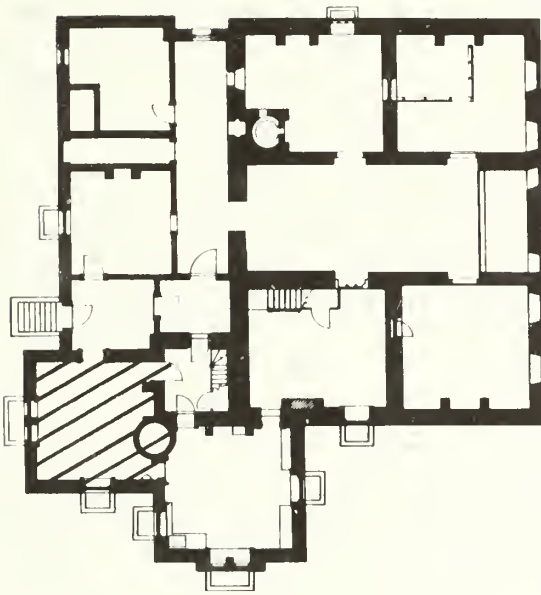
i. Room 007 - Laundry

Room 007 is in the southwest corner of the ca. 1850 addition. It was apparently the "wash room" referred to in Upjohn's specification for basement floors. This hypothesis is drawn from the survival of a hand pump and lead-lined wood sink on the south wall of the room. Also the uses of the other rooms in the ca. 1850 portion of the basement have already been determined, or the rooms do not have the water supply required for a washroom.

The south, west, and north walls of room 007 are coursed rubble masonry with built-in wood nailers for the attachment of furring strips. The east wall is brick

Restore all woodwork to a cream color (Munsell 5Y 9/2, Benjamin Moore GB-60).

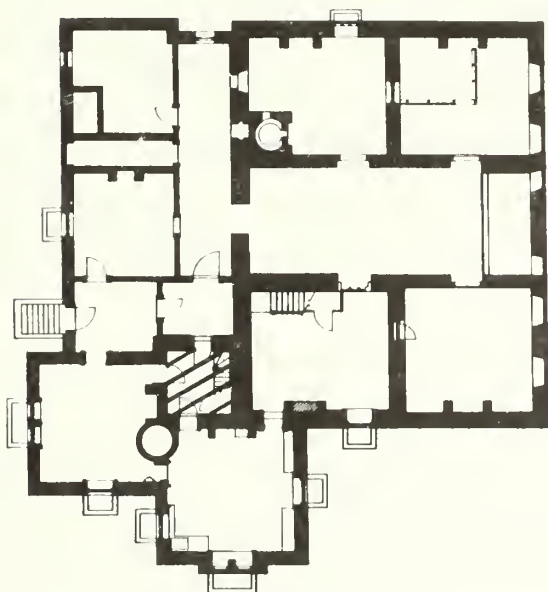
j. Room 008 - Stair Hall

Room 008 is the lowest level of the tower stair and the primary interior access to the basement. The walls of the room are whitewashed, two-coat plaster directly on masonry walls. The north and east walls are rubble stone construction; the south and west walls are brick. Aside from minor damage to the south wall (caused by rising damp) and to the northwest corner (probably caused by leaking pipes), the plaster and masonry are in good condition. The east wall under the stair consists of a board partition with a board-and-batten door, both of which have a painted wood-grain finish. The underside of the stair and the

east and south walls behind this board partition are finished with plaster and whitewash. Typical ca. 1850 baseboard for secondary spaces is found in the main part of the room and around the south and east walls under the stair, but not on the board partition. Thus, this partition is considered nonhistoric, as are similar partitions in room 005 and between rooms 113 and 117.

- Restore all woodwork to a cream color (Munsell 5Y 9/2, Benjamin Moore GB-60).

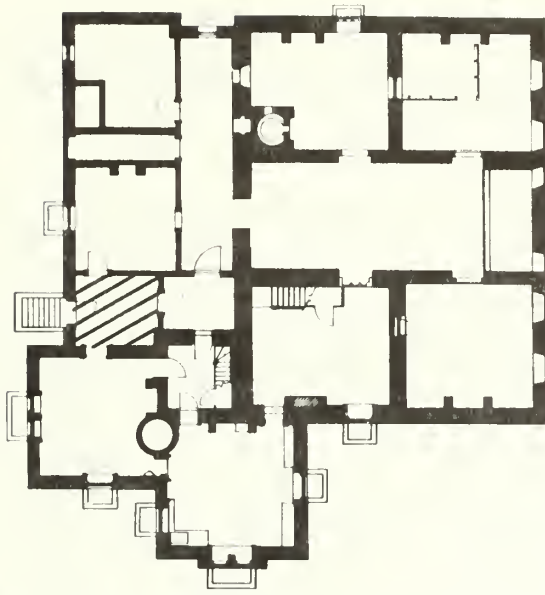
k. Room 009 - Basement Entry

Room 009 is a vestibule/entry space. Door 012 in the west wall of the room gives access to the bulkhead stair. The historic cesspool is under the floor of this room. There is also evidence that suggests the brick platform in the southeast corner may have supported a water heater.

The walls are masonry covered with two-coat plaster and light gray whitewash. The south and west walls are coursed rubble stonework, and the east and north walls are brick. At the southeast corner the stone foundation of the tower projects into the room. On the south wall just west of the tower foundation

Restore all woodwork to a cream color (Munsell 5Y 9/2, Benjamin Moore GB-60).

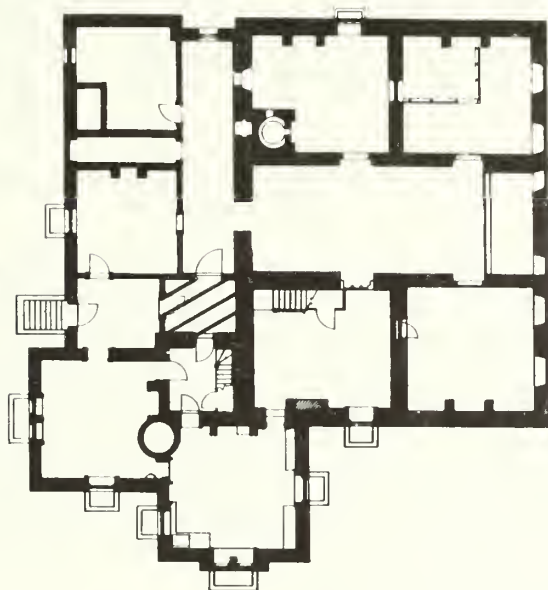
#### I. Room 010 - Transitional Space

Room 010 is east of room 009 and north of room 008. It is a small rectangular space 10' by 7'6" whose only apparent use is as a transitional space between rooms 008, 009, and 012.

The walls are covered with a two-coat plaster and whitewash. Except for minor cracks, a large area of missing plaster in the southwest corner, and a small area of missing plaster near the floor in the northwest corner, the plaster is in good condition. In the east wall there are two straight vertical cracks, extending from floor to ceiling, indicating an infilled door. The north jamb of this door was about

- Restore all woodwork to a cream color (Munsell 5Y 9/2, Benjamin Moore, GB-60).

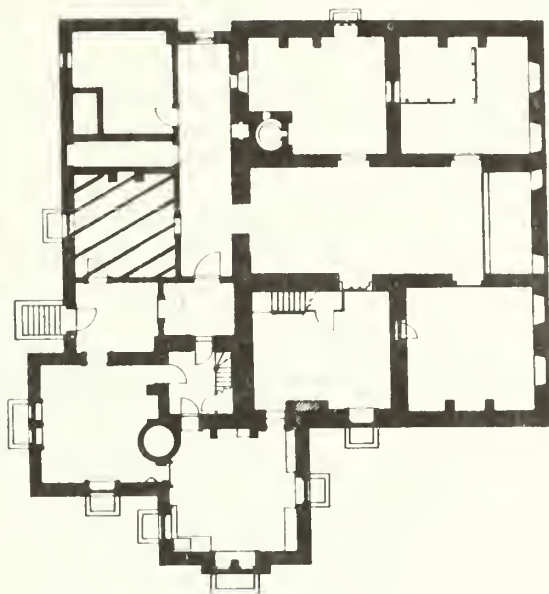
m. Room 011 - Chamber

Room 011 is along the west wall of the ca. 1850 portion of the basement, just north of room 009. There is no documentary evidence of its use, but the presence of a fireplace suggests that it was used for human habitation--possibly a servants' bedroom.

The walls of room 011 were covered with a whitewashed two-coat plaster. Plaster was applied directly to the brick on the north, east, and south walls and to wood lath over furring strips attached to wood nailers that were incorporated into the construction of the coursed rubble stone west wall. Plaster, lath, and furring strips are all

Restore all woodwork to a cream color (Munsell 5Y 9/2, Benjamin Moore GB-60).

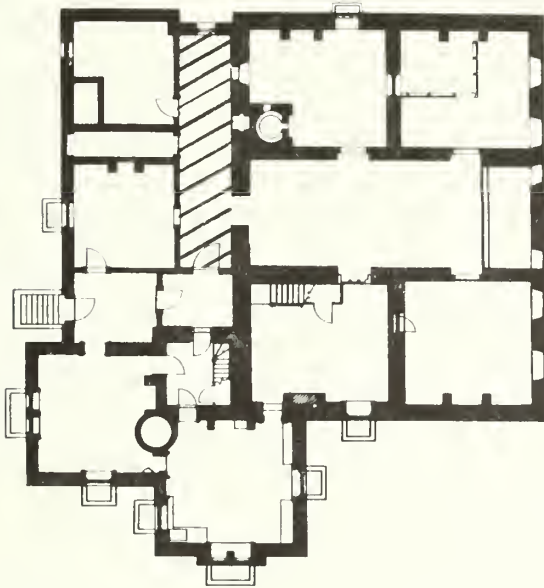
n. Room 012 - Back Hall

Room 012 is the back hall of the basement. It provides access from room 010 to rooms 003, 013, and 015. In recent years (and possibly earlier) it has been used as a storage area.

The south and west walls of room 012 are of brick construction with two-coat plaster applied directly to the brick. The plaster on the south wall is in good condition. On the west wall, plaster has deteriorated to a greater or lesser extent because of rising damp of variable intensity. The north wall is of coursed rubble stone construction similar to that of other exterior walls built ca. 1849. There is no evidence to

- Restore all woodwork to a cream color (Munsell 5Y 9/2, Benjamin Moore GB-60).

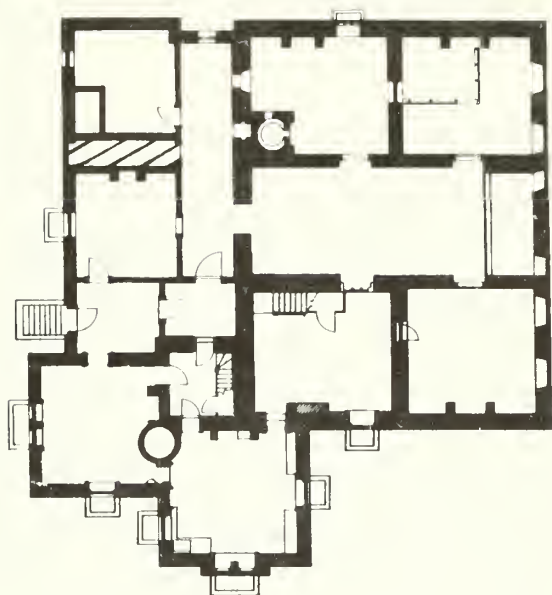
o. Room 013 - Vaulted Tunnel

Room 013 is a long, narrow room, 3'6" by 14'6", between rooms 011 and 015 (see IP024). It is bounded on the east by room 012 and on the west by the exterior foundation wall. Its historic and subsequent uses are a subject of considerable interest. The most plausible hypothesis is that this room and an adjacent small chamber to the west were used for cold food storage and ice storage respectively. The evidence supporting this hypothesis is presented in the following paragraphs.

The north and south walls of room 013 are of solid brick construction, three wythes (13") thick (compared to two wythes for adjacent walls). There is no structural reason for greater thickness, suggesting that insulation may have been the object of the thicker walls. The bond used in the brick work is American bond, with header courses at spacings ranging from three to six courses. There is no plaster on the walls and no evidence that there ever was. The end walls are completely dominated by door openings.

It is recommended that this room be preserved as is. If the room is to be interpreted to the public, door 010 should be opened and the room beyond should be reconstructed.

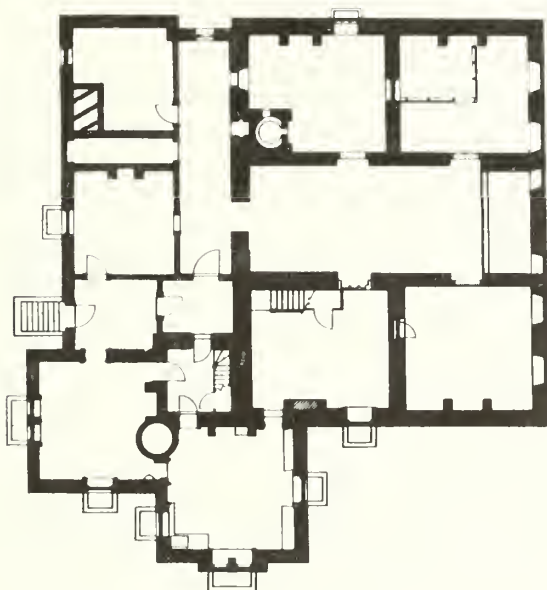
p. Room 014 - Privy Pit

Room 014 is not really a room at all. It is the interim repository for human wastes from room 121 pending their ultimate disposal in another place. It is along the west wall of the basement, adjacent to room 013 and seemingly carved out of the southwest corner of room 015. Interior dimensions are approximately 3'6" by 6'0". Its proximity to the ice and food storage areas seems unsanitary, but as demonstrated by the presence of the cesspool in room 009, either sanitation was not well understood by the architect and owner or it was not a matter of great concern.

The north, east, and south walls are of solid brick construction with a badly constructed stone lining that has partially collapsed and appears to be unstable. The west wall is the coursed rubble stone construction typical of ca. 1849 exterior foundation walls. The lower portion of the interior walls is covered with fill, which was partially excavated by Denver Service Center archeologists in the summer of 1978 (see NPS, Fiero 1983). A portion of the north wall either collapsed or was taken down. The resulting 3' radius hole is roughly the shape of a quadrant, with its center at the intersection of the floor of room 015 and the west wall.

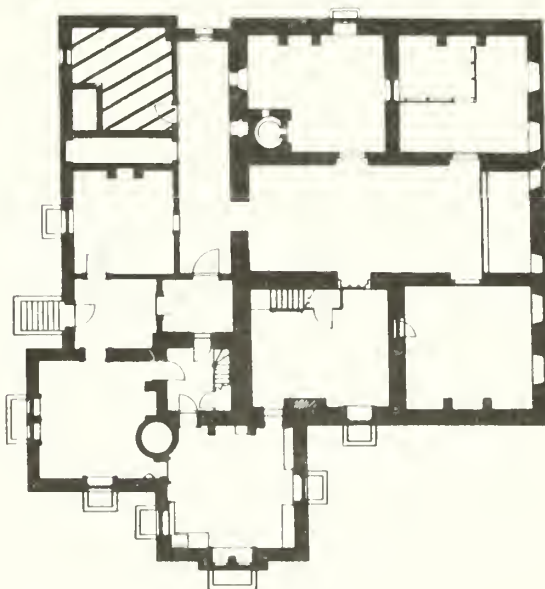
q. Room 015 - Coal Storage

Room 015 is at the northwest corner of the ca. 1850 addition to Lindenwald. The remaining piles of coal in the room, the bricked-in opening on the north wall (which appears to have been a coal chute), and its proximity to room 001 suggest that this room may have been used for coal storage during the historic period.

The floor of room 015 is paved with brick, and areas of the brick are covered with a lime mortar wash approximately 1/2" thick. The broken edges of this wash and the dispersed locations of the surviving areas suggest that at one time the entire floor was covered with this material. The floor is 7" to 8" lower than the floor in room 012.

The preservation and restoration work recommended for room 015 includes the following items:

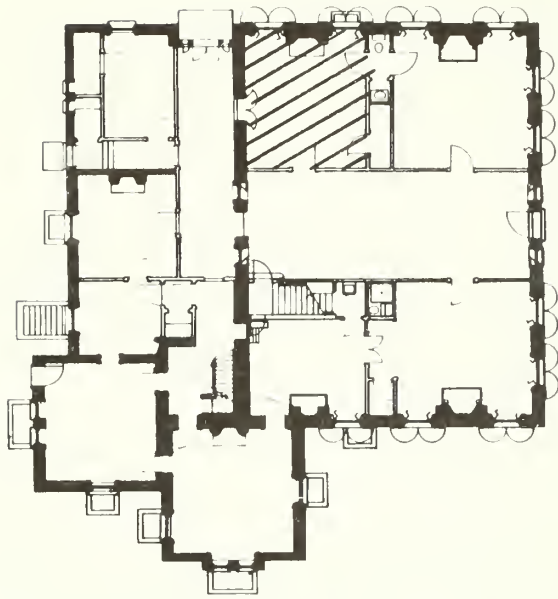
### a. Room 101 - Bedroom

Room 101 is in the northwest corner of the 1797 house. Direct access is from the 1797 central hall, room 105, on the south wall (D101). Door 104 at the north end of the east wall opens into a small closet, room 102, and allows one to pass into the northeast room 104. Originally room 102 was connected to a larger closet, room 103. A door opening in the west wall has functioned as a closet since 1849 (D105). The north wall has a central chimney breast and windows (W109, 110) at either side.

Van Buren, as in other 1797 rooms, also removed the chair rail in room 101. Its location is evidenced by plaster infill and irregularity. This change is assigned to Van Buren work of the early 1840s because of conclusive evidence found in rooms 105 and 109. Van Buren, in ca. 1854, installed a floor register for hot-air heat in the southwest corner. A stovepipe hole also was cut in the chimney breast, probably after the historic period.

The following preservation and restoration work is recommended to return room 101 to a bedroom:

Make miscellaneous plaster repairs, including plumbing and stovepipe hole patching.

Repair window shutters and replace hardware for all pulls, several butt hinges, and sash locks; repair jamb stops.

Restore the ceiling using a calcimine finish.

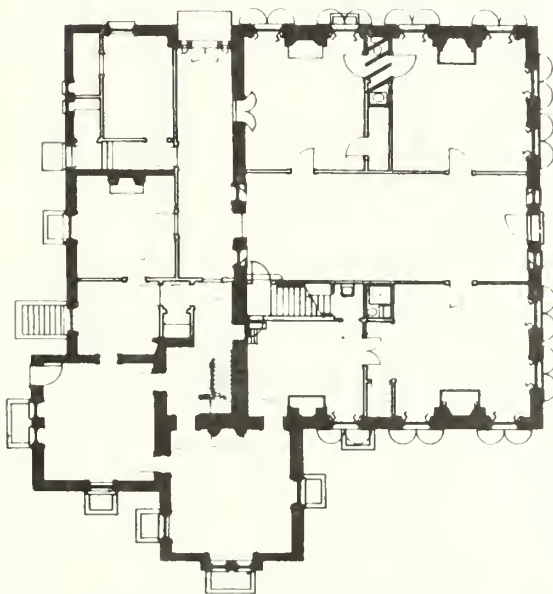
b. Room 102 - Bathroom

Room 102 is a small space between the two north rooms of the 1797 house. The space is formed by two parallel walls dating to 1797 that run in a north-south direction between rooms 101 and 104. A larger space, room 103, shares this enclosure south of room 102.

The preservation and restoration work recommended for room 102 includes the following items:

Restore the north wall door and casing to a cream color (Munsell 5Y 9/2).

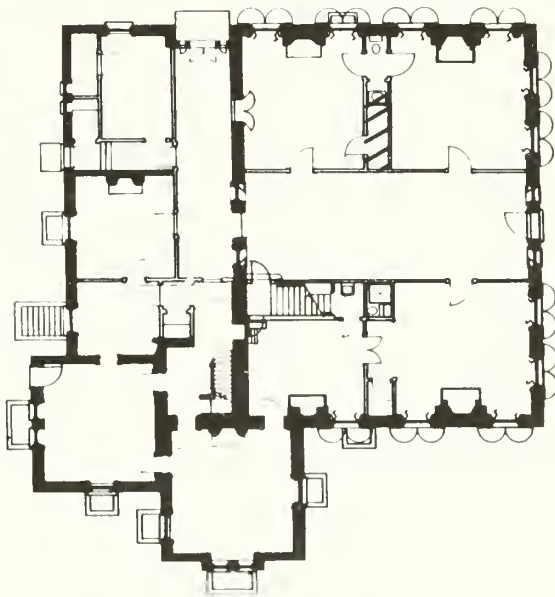
c. Room 103 - Closet

This room is a companion closet to room 102. It is a larger space that was originally constructed with its door opening on the south of room 102. Markings on the east wall indicate that it was originally lined with shelves. The shelves were 9'7" long, 7'4" high, and 1'½" wide and were placed approximately 1'5" apart. On the west wall there was a pegboard set into the plaster brown coat.

This space was altered sometime during the DeProsse residency to accommodate modern plumbing fixtures. The north end of this closet was converted into a sink alcove using a board partition to

The following preservation and restoration work is recommended to restore this closet:

Restore the north wall door and casing to a cream color (Munsel 5Y 9/2).

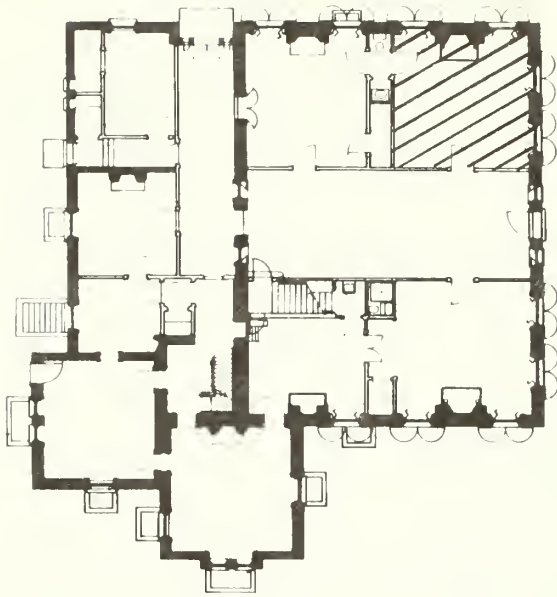
d. Room 104 - Parlor

This room occupies the northeast corner of the 1797 house. It is entered from the central hall, room 105 (D102), and also has access to closets 102 and 103 and through to room 101. The east (front) wall has two window openings (W105, 106), and the north wall has a central chimney breast flanked by window openings (W107, 108).

Changes in the decorative wall finishes in room 104, beginning with the ca. 1840 Van Buren period, are supported by both physical and documentary evidence. In 1978, when a large pier mirror was removed from between the east wall windows of room 104, a large section of early wallpaper, extending from the baseboard to several inches above the window casing, was found. This wallpaper is composed of black star motifs on a gray ground (005). In areas where the chair rail was removed, it is lined with the green paper associated with Van Buren's work in room 105 and therefore has been dated to 1841. This black star wallpaper is described in the 1936 Weig report as an "original wallpaper [star design-green border]" (NPS, Weig 1936, 47). Two photographs dating to ca. 1930 (HP19 and HP34) confirm that the paper was still on the walls, with small portions missing on the chimney breast. The mirror, behind which the wallpaper was found, was probably installed during Van Buren's residency. It required removal of the 1797 baseboard and chair rail and chiseling of the floorboard to half its depth to receive it.

Other changes in room 104 include the ca. 1854 introduction of a hot-air register in the south end of the west wall (see IP026 and section IV.C.), radiators on the east and north walls, and varnishing of the wood floor ca. 1960.\* Previous insect damage, from wood bores and silverfish, may be found on the floors and the east wallpaper.

The following preservation and restoration work is recommended for room 104:

- Replace the plaster cornice astragal molding.

- Make miscellaneous plaster fills and repairs.

- Remove the cast-iron backing and investigate the masonry condition.

- Reconstruct the missing shutter leaf.

Replace the missing hardware: four shutter pulls, two butt hinges, and the shutter bar.

Remove the wood floor varnish.

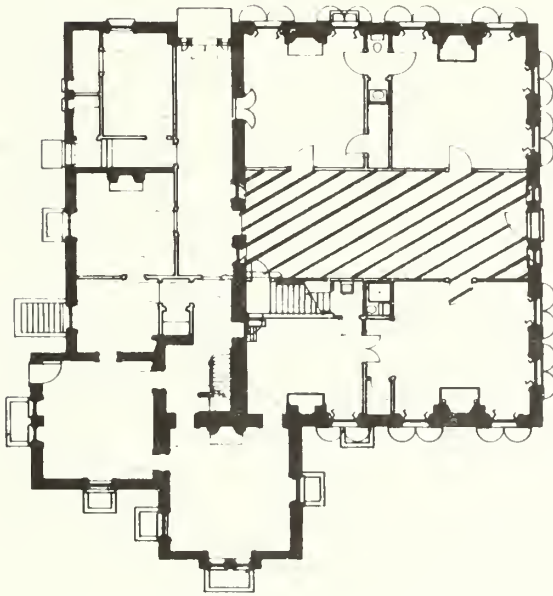
e. Room 105 - Banquet Hall

This room occupies the entire depth of the central portion of the first floor within the 1797 structure. Its original function was as an entrance hall both from the front (east-D101) and the back (west-D108) into rooms on the north and south and as a stair hall to the second floor.

Subsequent intrusions include hot-air heating system registers ca. 1854, one midway in the north wall baseboard and one in the northwest corner of the floor. A later register (ca. 1840), 3'4" square, associated with a kerosene burner, was also installed in the northwest area of the floor. There is a hot-water radiator in the southeast corner. Recent plaster patching around the east entry door may relate to the ca. 1849 porch and its deterioration.

The preservation and restoration work recommended to restore room 105 includes the following:

- Repair the plaster cornice.

- Consolidate and repair the plaster walls.

- Restore the hot-air registers (ca. 1854) in the north wall baseboard and northwest corner of the floor.

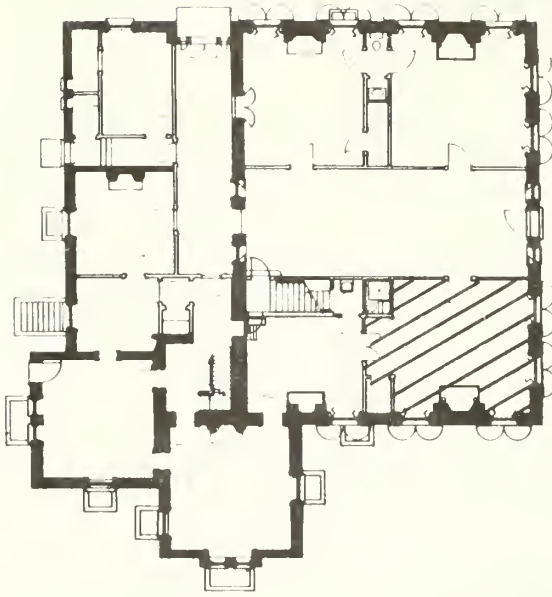
f. Room 106 - Parlor

Room 106 occupies the southeast corner of the 1797 house. It is entered through a door opening in the north wall (136) from the central hall, room 105. Two window openings are in the east or front wall (101, 102), and a chimney breast flanked by two windows (126, 127) is in the south wall. An ogee arch in the west wall frames an alcove with double doors (133) leading into room 109 and includes side doors (135, 134) into two small closets, rooms 107 and 108, respectively.

Replace one shutter pull.

Reproduce the missing knobs for door 134.

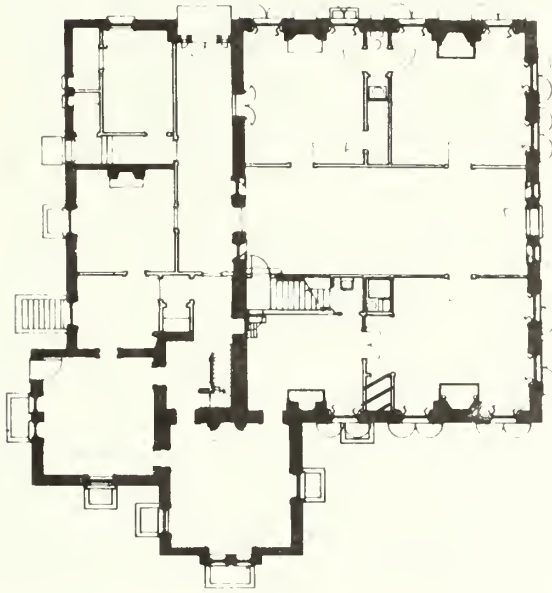
g. Room 107 - Storage

Room 107 is a small closet on the south side of the 1797 house between rooms 106 and 109. This closet is entered through a door opening (135) in the north wall from an alcove in room 106, the drawing room. Rooms 107 and 108 maintain a symmetrical relationship with rooms 102 and 103 on the north side of the central hall, room 105. The treatment of the four closets is different, however.

Changes in room 107 include a reworking of shelves and holes in wood and plaster to accommodate heat and water supply pipes. All remaining fabric in this closet is from the 1797 period of construction.

Restore all woodwork to a cream color (Munsell 5Y 9/2, Benjamin Moore GB-60).

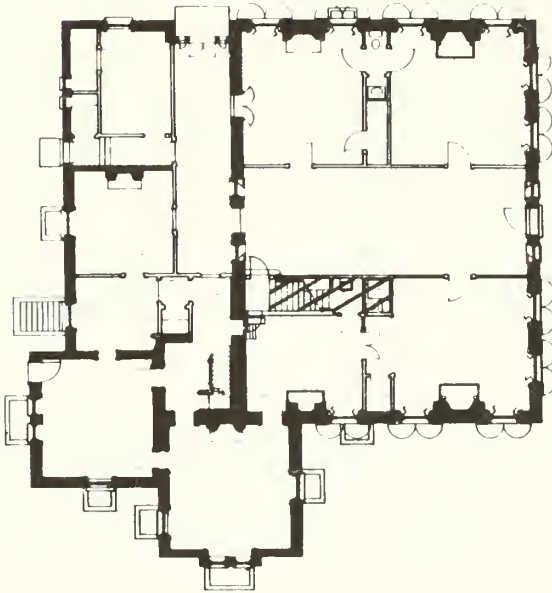
h. Room 108 - Closet/Stair/Bath

Room 108 is a small closet between rooms 106 and 109 on the north. There are three door openings into this closet, including a door from the room 106 alcove (D134), a door from room 109 (D132), and a door on the west wall into a stair hall leading to the basement room 005 (D131).

The major change in this closet appears to have occurred when the central hall stair was relocated by Martin Van Buren in the early 1840s. The physical evidence suggests that the stair access into the basement was relocated to maintain the parallel relationship between both sets of stairs.

- Replace and repair the baseboards.

Reproduce the gold-striped wallpaper (006) and its border.

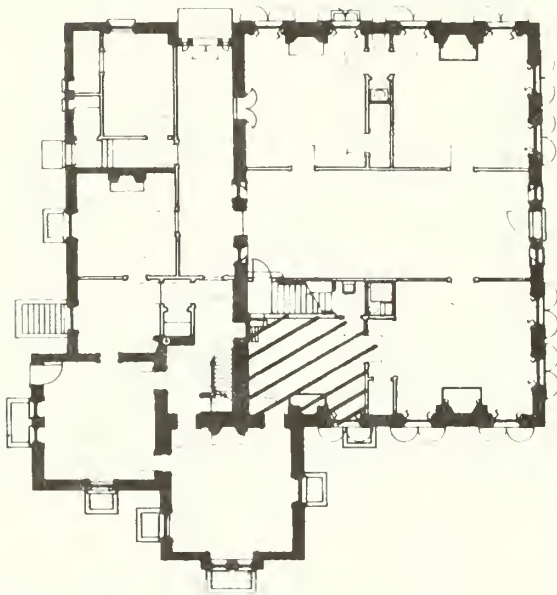
i. Room 109 - Library/Den

Room 109 is in the southwest corner of the 1797 house. In plan it is symmetrically opposite to room 101, a Van Buren bedroom. Although their functions appear to have differed, the decorative treatments for rooms 101 and 109 were similar. These rooms were secondary to the more formal front rooms (104 and 106) and central hall (105).

Reproduce the gold-striped wallpaper (006) and its border; restore the fireboard and reproduce the scenic panel.

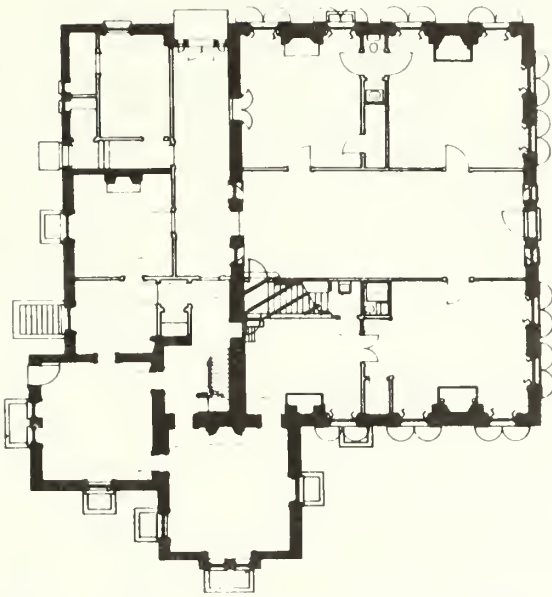
j. Room 110 - Stair

Room 110 is the number that has been assigned to the stairs that run from room 105 up to room 206. These stairs are located between rooms 105 and 109 in an area that was originally part of room 109. The north wall of the stairs is the 1797 north wall of room 109. Access on the first floor is from rooms 105 and 109; on the second floor it is only from room 206.

Restore the ceiling to a finish plaster white coat.

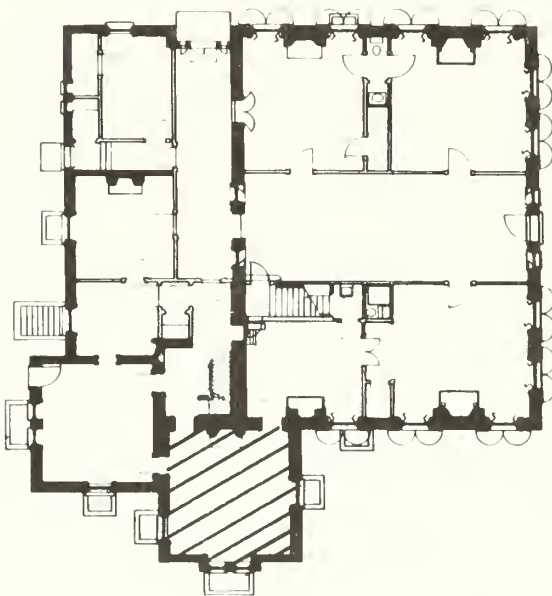
k. Room 111 - Library

As part of the 1849 additions designed by Upjohn, this room is assumed to have been the library. The plan records of Upjohn's office include details for the bay window of the library (Upjohn Planbook), and room 111 is the only first-floor room with a bay window. This room adjoins the south side of the 1797 house so that access is not only from room 113 (D126), the tower stair hall, and the bedroom, but also from room 109 (D128), the breakfast room.

Restore all plaster wall surfaces with a brown paint (Munsell 10YR 6/4, Benjamin Moore CB-9).

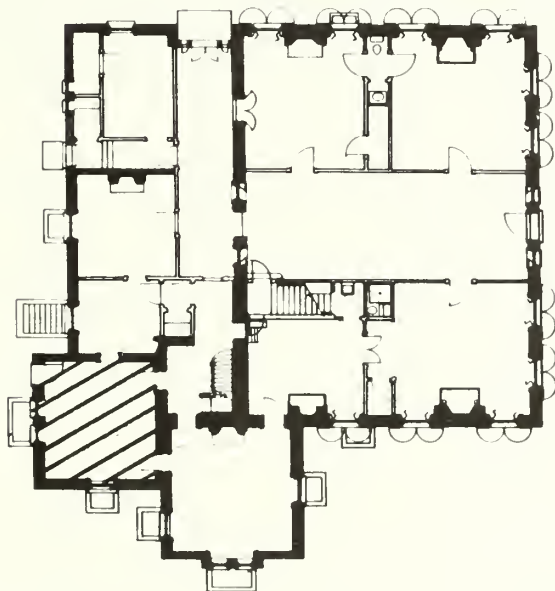
#### I. Room 112 - Bedroom

This room projects farther west than the other portions of the one-story 1849 addition. It is under its own batten-seamterneplate gable roof immediately to the west of the tower. The room may be entered from the tower stair hall, room 113 (D125); the library, room 111 (D127); the bathroom, room 114 (D122); and from an exterior door in the west wall (D124). There is one window in the south wall, a double-arched window in the west wall, and a fireplace in the east wall.

The records of Upjohn plans refer to details for a bedroom double window and a cornice for a bedroom. There is no other room that meets both criteria. A letter of October 4, 1849, from Barney McGuire to Richard M. Upjohn confirms the bedroom designation: "The Bedroom fire place has no projection. The opening of the fire place is 2'-5-3/4" (Upjohn Papers). Although this room probably functioned as a bedroom for Smith Thompson Van Buren, its later uses have varied considerably. In fact, no other space designed by Upjohn experienced to as much fabric alteration and deterioration as this room.

Patch all stovepipe openings in the ceiling.

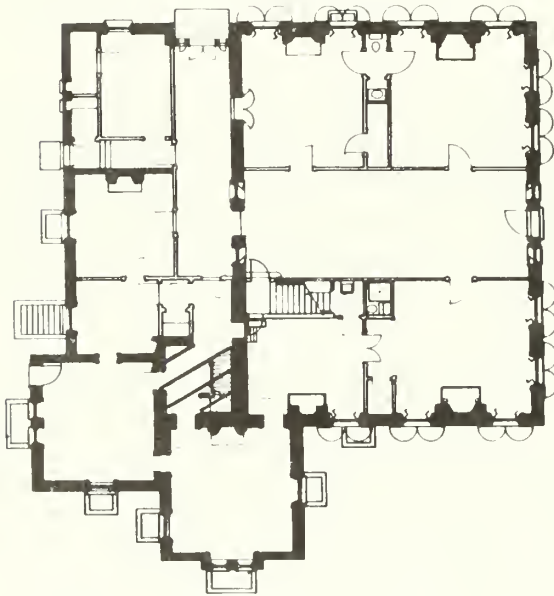
m. Room 113 - Tower Stair

This room originally joined room 117. A board partition (see IP035) divides the space and is described here as a separate room. It functions as the tower stair hall that provides access to the basement and upper floors--room 111 (D126), the library, and room 112 (D125), a bedroom.

Correspondence from Smith Thompson Van Buren to Upjohn documents the staircase design problems that can be seen today (Van Slyck to Richard Upjohn, October 23, 1849, and Smith Thompson Van Buren to Richard Upjohn, November 22, 1849, April 20, 1850, and May 17, 1850,

Restore the stair tread and risers to a light brown color (Munsell 10YR 6/2, Benjamin Moore ET-45).

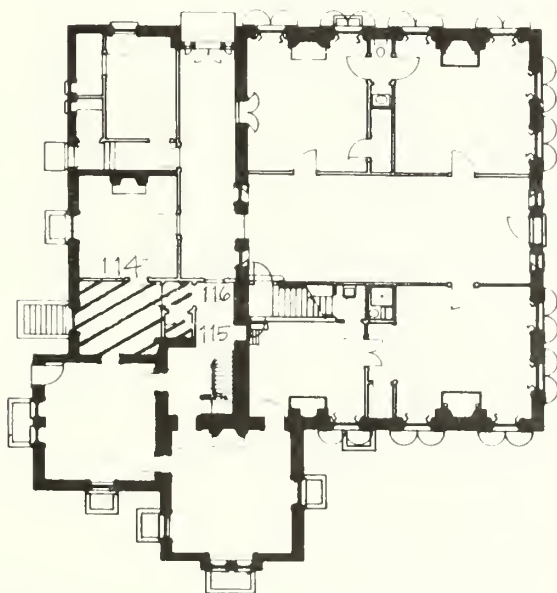
n. Rooms 114/115/116 - Bathroom/Water Closet/Access

Rooms 114, 115, and 116 are the three rooms that comprised the bathroom. (How the bathroom functioned is described in section IV.C.3.). They are roughly at the center of the west side of the one-story 1849 addition.

Room 114 contained a sink, bathtub, and dressing area. At present, the room may be entered from the bedroom, room 112 (D122); a small access hall, room 116 (D117); the nursery, room 118 (D116); and an exterior door in the west wall (D123). Room 114 has a window in its west wall and a fireplace in its southeast corner.

Restore the plaster ceiling and cornice using a finish plaster white coat.

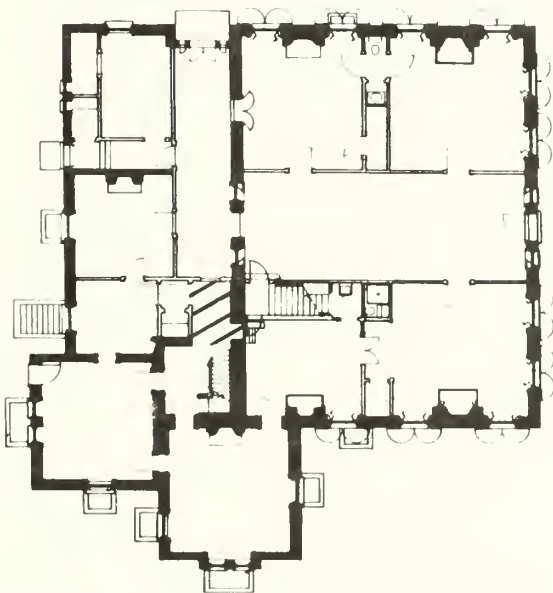
o. Room 117 - Hall

This hall was added as part of the 1849 additions, and although it is currently divided from the tower stair hall, room 113, they were originally connected. The arched opening between rooms 113 and 117 was filled in with a vertical board partition, probably by the Wagoner family in the last quarter of the 19th century. The date of this alteration is supported by paint, hardware, and molding evidence.

Check the floor joists in relation to downward movement, and monitor cracks.

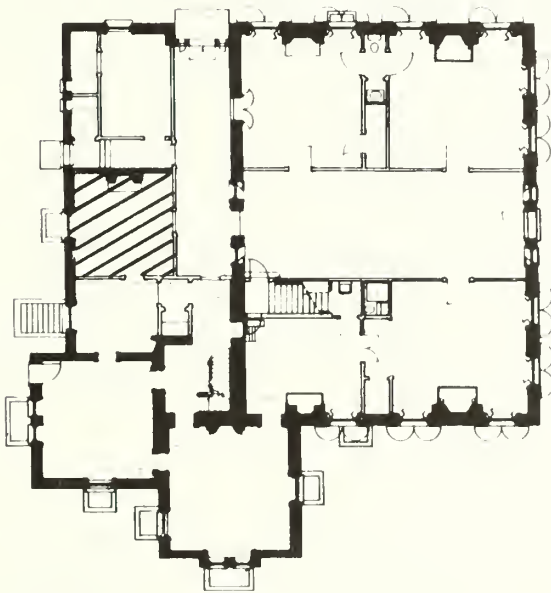
p. Room 118 - Nursery

Room 118 is directly to the west of the 1797 central hall, room 105, and between the small hallway, room 120, on the north and the bathroom, room 114, on the south. The entry for May 30, 1849, in Upjohn's planbook lists "cornices of hall, nursery, bedroom and bathroom." Having identified the hall, bedroom, and bathroom, Room 118 is the only remaining space with a cornice molding. Barney McGuire stated in a letter of October 4, 1849, to Richard Upjohn that the width of the chimney breast in the nursery was 5'4". This corresponds to the present condition in room 118.

- Study further to determine the southwest furniture piece and the floor markings in the northeast corner.

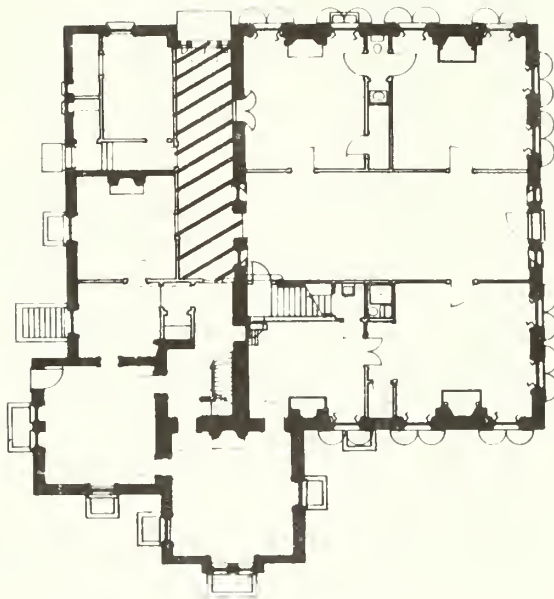
q. Room 119 - Hall

Room 119 is an entrance hall approximately 33' in length along the northern portion of the west wall of the 1797 house. This hall was added as part of the 1849 work. Entry from the exterior is through a double-door opening in the north wall (D109). Access from this hall is provided by two doors in the west wall--one to room 120, a hall (D114), one to room 118, nursery (D115)--and by a former exterior door opening in the east wall (D108) leading into the central hall, room 105.

Remove the varnish from the wood floor.

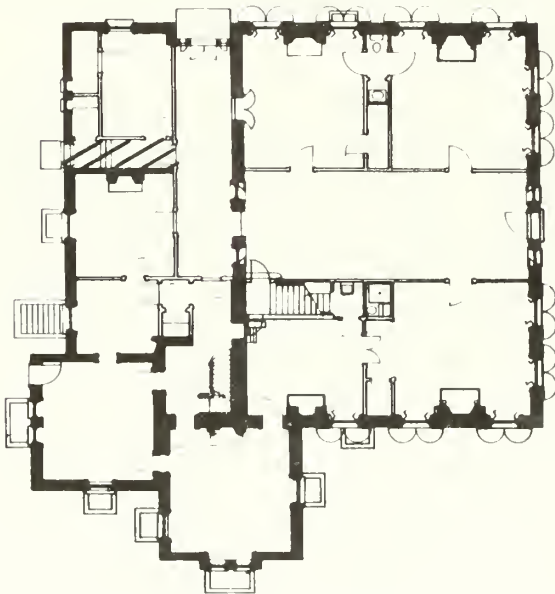
r. Room 120 - Hall

This hallway in the 1849 addition runs in an east-west direction. Before other door openings were added in the latter part of the 19th century, this hallway provided the only exit from the first floor to the west, or back, side of the house. The space is perpendicular to and midway along the west wall of the large Upjohn entry hall (room 119). Access from other parts of the house is through room 119 only (D114). This small hallway, in addition to providing an exit to the exterior, provides access to room 123, a bedroom (D113), and room 121, a privy (D121).

Changes in this hallway are primarily a result of roof deterioration. More than 50 percent of the plaster ceiling is missing because of water damage. Drainage problems along the west wall gutter system also caused masonry settlement. The diagonal cracks in the west wall plaster can attest to this problem.

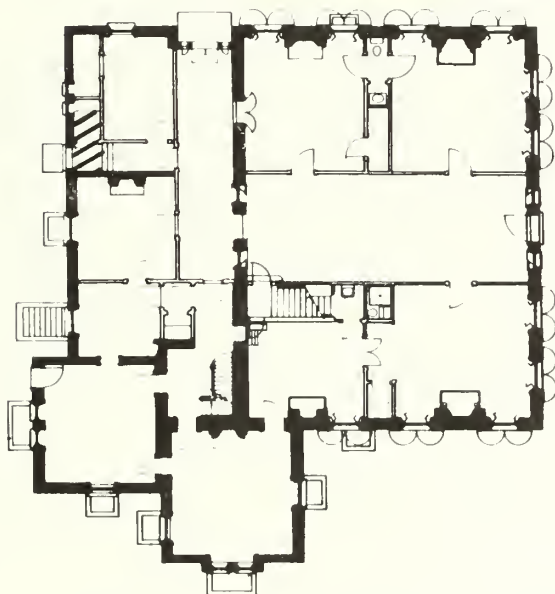
s. Room 121 - Privy

This privy has remained in its original form since ca. 1849 (see IP041). It has a wood-encased seat above a stone-lined privy well. The built-in seat is composed of one horizontal, recessed panel with molding on the vertical front and four similar panels with the cyma recta molding on the top or horizontal surface. One larger panel on the top is butt-hinged for the seat opening.

The preservation and restoration work recommended for room 121 includes the following items:

Remove a board with hooks on the east wall, if it is found to be nonhistoric.

Replace the door (111).

Restore the painted wood surfaces to a cream color (Munsell 2.5Y 9/2 Benjamin Moore GB-30).

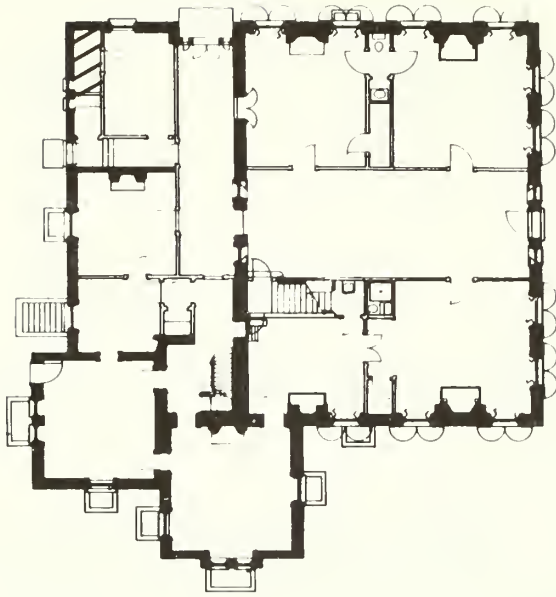
t. Room 122 - Storage

This closet occupies the northwest corner of the ca. 1849 addition. It is entered from a small bedroom, room 123 (D110).

There does not appear to be a built-in or attached system for hanging clothes or for storage except for one shelf at the north end. Neither the shelf nor several ledger strips appear to be original.

Remove molded ledger strips secured to the north and west walls for further investigation; replace these ledger strips with strips matching those on the east wall.

Remove the metal patch along the west wall; assess and repair any deterioration to which it may be related.

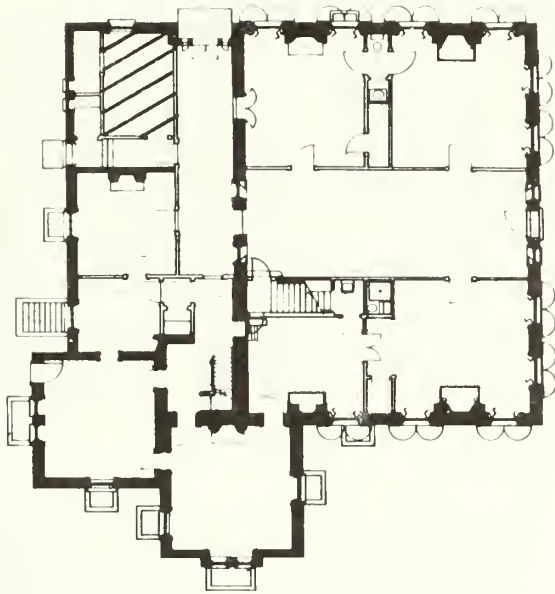
u. Room 123 - Chamber

This is a small, rectangular room at the north end of the Upjohn addition, which is entered from a small hallway, room 120 (D113), and has a large, attached closet (room 122). The simplicity and size of the space suggest a children's or servants' bedroom. No plans or detail drawings are listed in Upjohn's planbook for this room that would support a specific function.

Except for several minor repairs that are needed, room 123 is in its original form. There is no fireplace or cornice molding. The finish woodwork for two door openings, one north wall window opening, and the baseboards is

- Repair the sliding shutter.

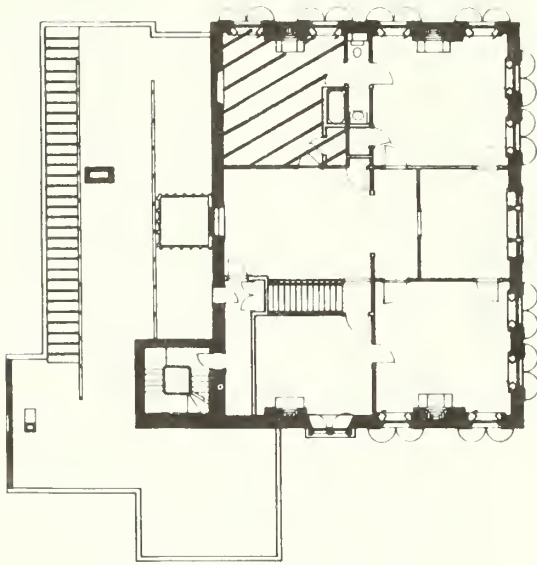
#### a. Room 201 - Guest Chamber

This second-floor bedroom is in the northwest corner of the ca. 1797 house. Access is from the central hall, room 206 (D209). A door opening in the north end of the east wall (D207), leads to a closet, room 203, and also permits passage through to the northeast bedroom, room 205. There are two windows (210 and 211) flanking a chimney breast in the north wall and a cabinet in the west wall location of a ca. 1797 window opening (W212).

The earliest change that has been noted in room 201 was the removal of all chair rails. The evidence consists of horizontal plaster infill at an approximate height of 35". This change occurred in all major rooms of the ca. 1797 house and has been associated with ca. 1840 work of Martin Van Buren. The case supporting this date and the association with Van Buren is well documented in rooms 101, 105, and 109 (see section IV.B.2).

Repair and stabilize the plaster wall and ceiling in areas where the ca. 1960 lowered ceiling intervened and above window 212 where roof deterioration caused water leakage.

Replace missing butt hinge parts, and hang window 212 doors.

Remove the 20th century sash locks, and replace them with reproductions.

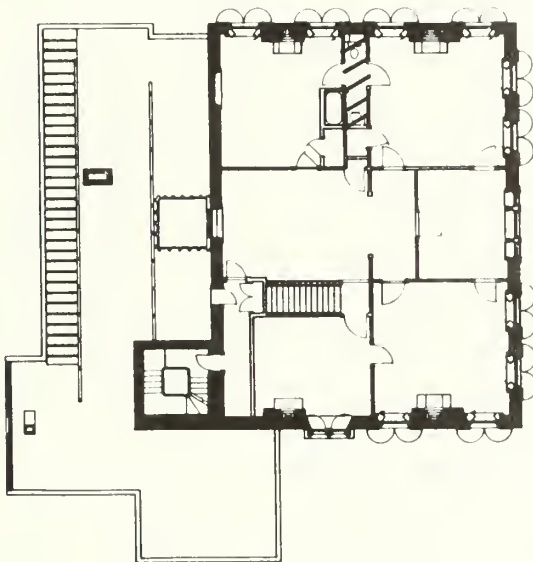
b. Rooms 202/203/204 - Closet/Bathroom/Closet

Room 202 was a closet built in the southeast corner of room 201 by Campbell, ca. 1960. This enclosure was removed by the park maintenance staff in 1978.

Rooms 203 and 204 are secondary spaces between the major north bedrooms, rooms 201 and 205. Room 203 (north of room 204) was enlarged to receive a bathtub by relocating a portion of the west wall farther west. This ca. 1960 work included the closet construction that created room 202. Plumbing for the toilet and sink fixtures in room 203 has been attributed to the DeProsse family through oral history and the 1938 DeProsse drawings.

Replace the floorboards.

Replace several baseboards.
